SERVICE INFORMATION

PROBLEM: Neutral Positioning Bolt Boss Too Short

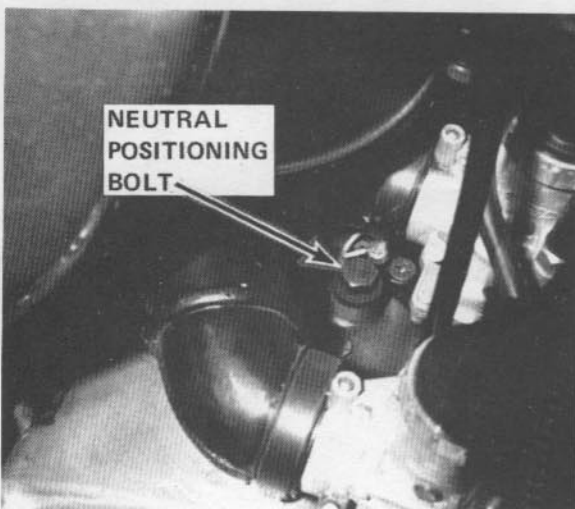
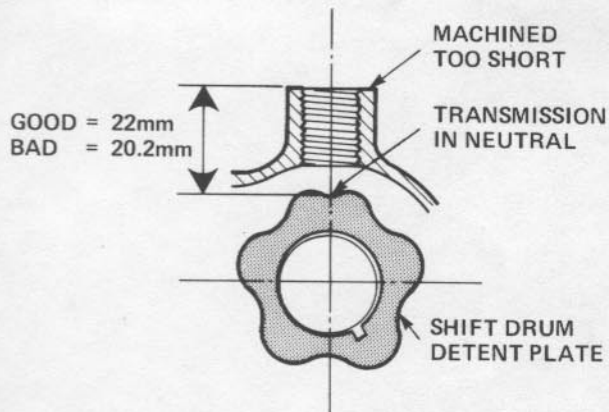
The 1976 KH500 has a neutral positioning bolt on the upper crankcase. On some early KH500's, the positioning bolt boss was machined too short. Installation of the positioning bolt and pin in a short boss may interfere with normal gear changing.

All affected units have an added gasket and washer under the neutral positioning bolt.
