### PROBLEM:

Rear wheel spoke breakage can occur on 1969-71 H1's, when rider operation is very demanding. Hard acceleration and braking impose great tensile (pulling) stresses on the rear wheel spokes. Breakage happens most often when the pavement is alternately wet and dry, such as accelerating through an underpass, where the tire may spin on wet pavement or gravel and then "grab" when passing onto dry pavement. Generally, the spoke breaks at the bend near the hub end.

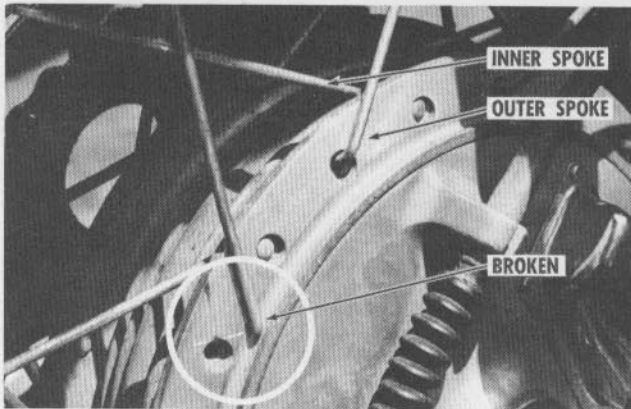
EARLY H1 STRAIGHT-TYPE SPOKES

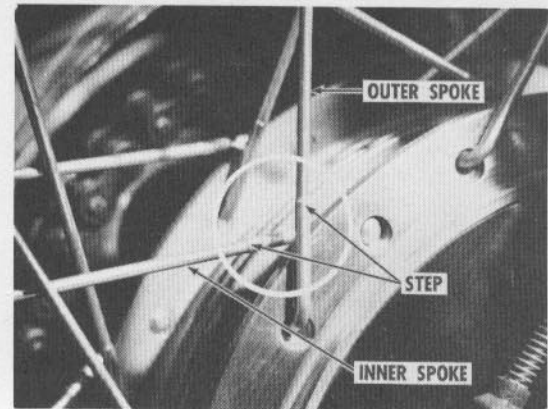
LATE H1 STEPPED-TYPE SPOKES

On all H1's after frame number KAF-47245, the rear wheel spokes are changed for more strength. The gauge of the spoke is increased from #9 to #8 at the hub end.
