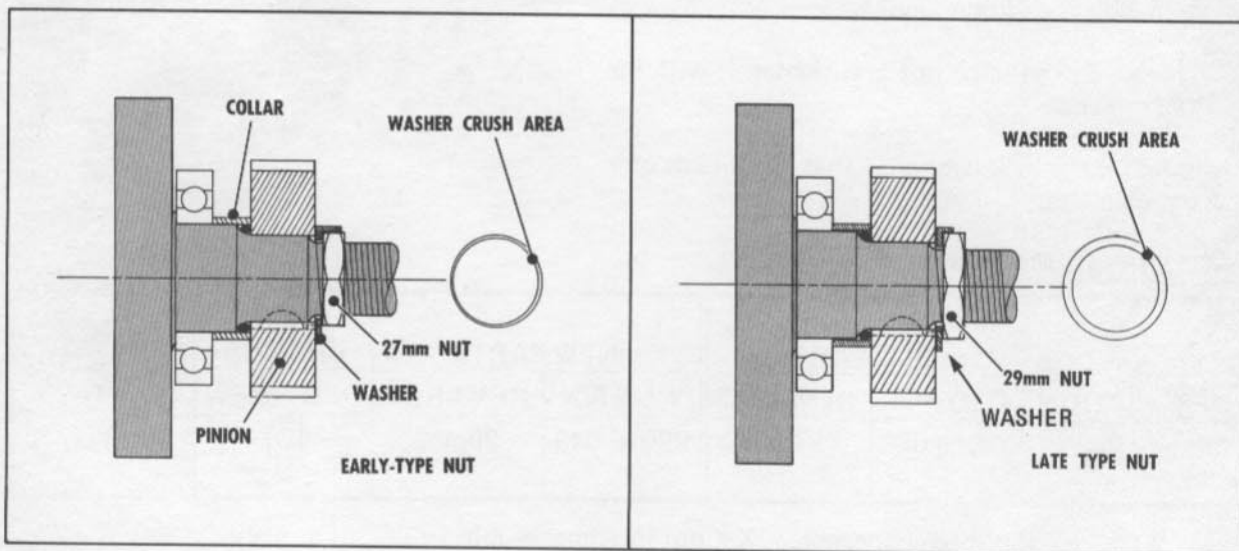
Surprisingly, the primary pinion nut does not loosen (turn) on the crankshaft. Instead, the lockwasher is crushed, relieving the pinion of nut tension. Then the gear is held from twisting only by the woodruff key. As the drawing below shows, the "crush" area on the lockwasher, which is determined by the I.D. of the pinion gear and the O.D. of the pinion nut, is very small.

The knocking results from the pinion keyway hitting the woodruff key as the pinion twists on the crankshaft.

A new larger nut, with a 29mm O.D., is used to increase the lockwasher crush area and eliminate washer extrusion. The larger nut has been installed in all H2's after engine number H2E-05228.
