PROBLEM:

CORRECTION:

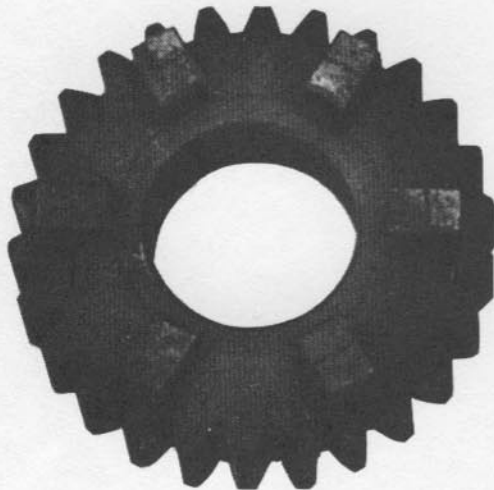
OLD

In the transmissions of H1 models there is a possibility for unusually fast wear on the inside of top gear on the drive shaft. As the gear wears, it begins to wobble on the shaft, eventually causing serious trouble in the transmission.

Top Gear
 (No Bushing)
 P/N 13136-022

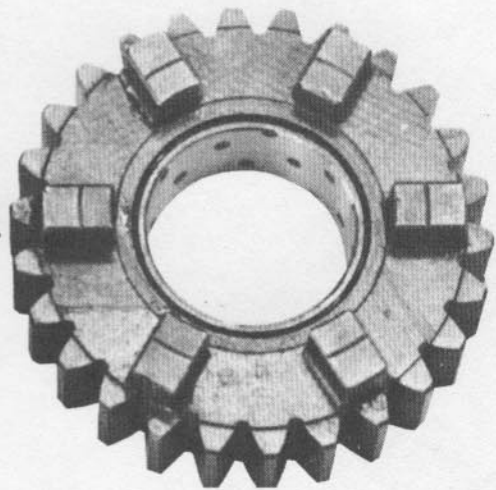
NEW

Top Gear
 Bronze Bushing
 P/N 13136-041

To eliminate this possibility, top gear on the drive shaft has been changed. The new gear is made with a pressed in bronze bushing for extended life. This change has been applied to all H1's in production from frame number KAF-57161, and to all H2's from beginning of production.
