Date: 9-20-73 N

BULLETIN SER 73 H-25

Title: H2 SWINGING ARM MODIFICATIONS

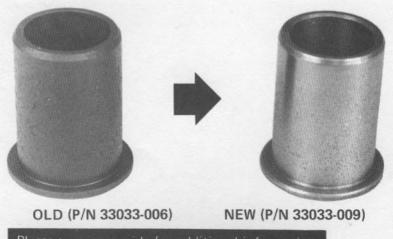
The rear cushion bracket on the H2A swinging arm is welded 5mm to the rear of the H2 bracket position. The H2A swinging arm has seven chain adjustment marks as opposed to six for the 1972 H2. Otherwise the two swinging arms are identical.

The H2A pivot shaft has a smooth polished surface as compared to the H2 pivot shaft which has a semi-rough machined surface.

The H2 uses phenolic bushings made of a cotton or asbestos filler bonded with a phenolic resin. The H2A uses sintered iron bushings for better resistance to wear and fracture. The sintering process produces a spongelike structure in the metal making it capable of absorbing 20 percent of the total volume with lubricant. This type of bearing is ideal in areas where lubrication is infrequent.
