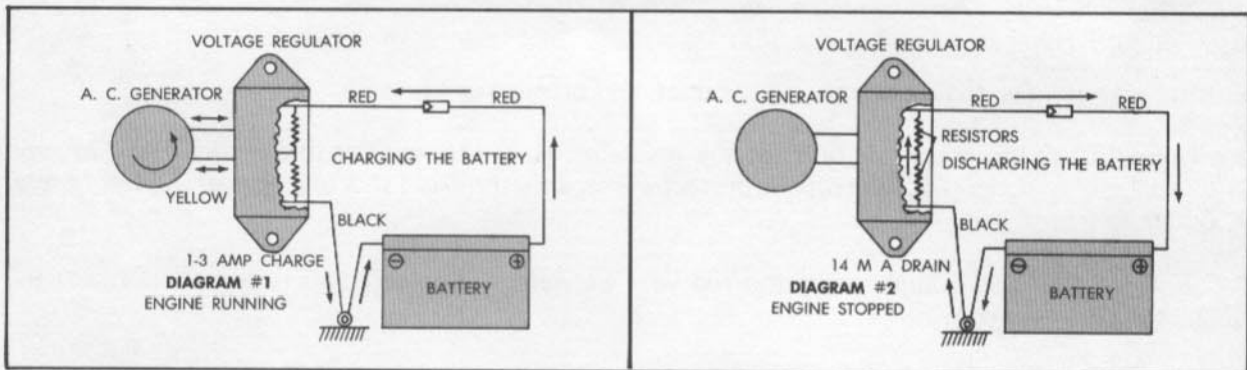
The H2 voltage regulator is connected to the battery by a red wire. This red wire carries the battery charging current when the engine is running. Because of two small resistors in the regulator circuitry, there is a slight current drain on the battery when the engine stops. In a fully charged state, it would take 2-3 weeks of inactivity for the battery to reach a serious discharge condition, because the current draw is so small (12-16 MA).
