PROBLEM:

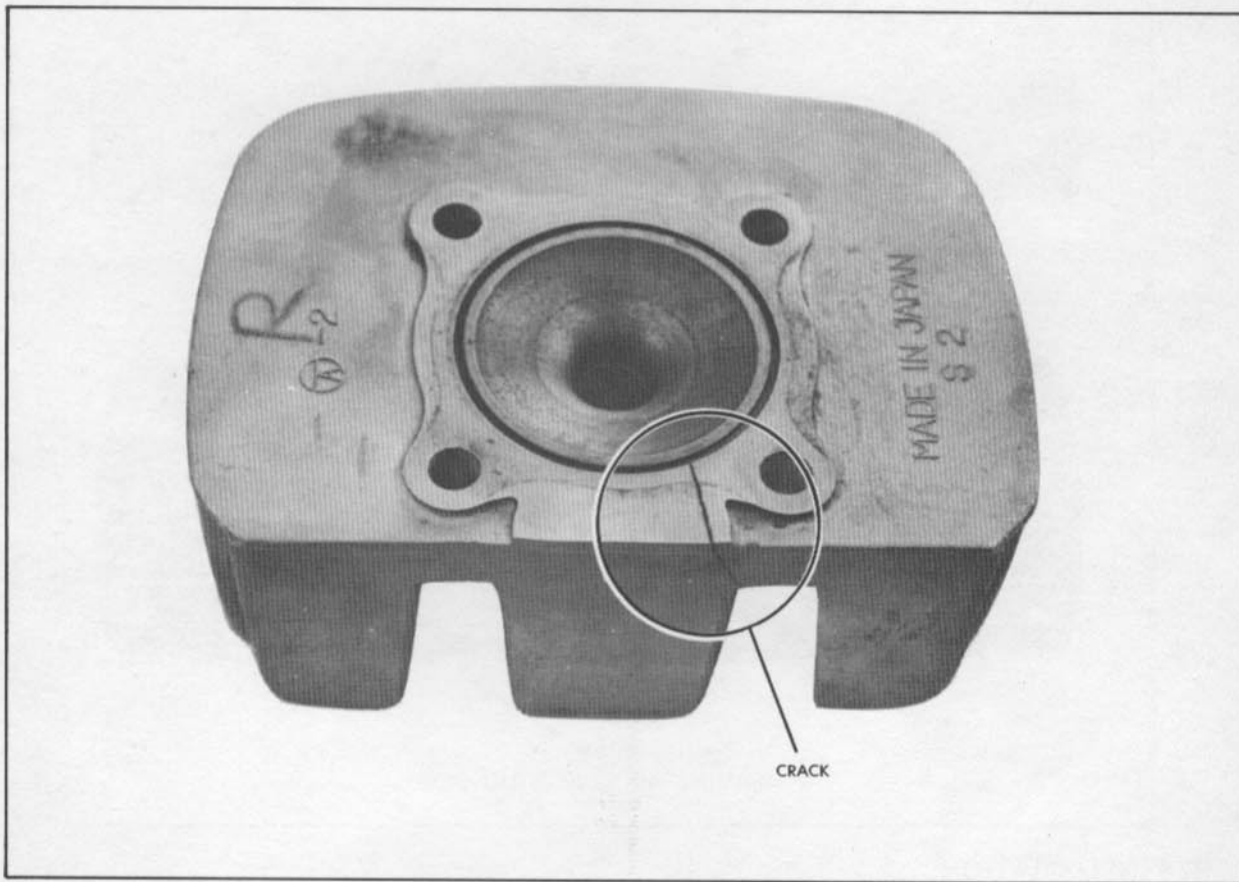
On some early S2 machines, there is a slight possibility of the cylinder heads cracking as shown below. Our experience indicates that the fault may occur under conditions of hard usage, such as extended full throttle operation for long periods of time.

With a cracked cylinder head, there is a slight power loss in the high RPM range in 4th and 5th gear. On some units the engine may detonate because fuel/air mixtures are upset from leakage. Generally, a cracked head will not be visually noticeable unless the head is removed from the engine.

All replacement cylinder heads in parts stock are thicker to prevent this problem; the part number is unchanged. The differences are illustrated below for identification purposes. A cracked head should be replaced immediately. Although all three heads need not be changed, they should be inspected for cracks and retorqued to 18 lb.-ft.
