©Kawasaki Motors Corp 1974 Printed in USA

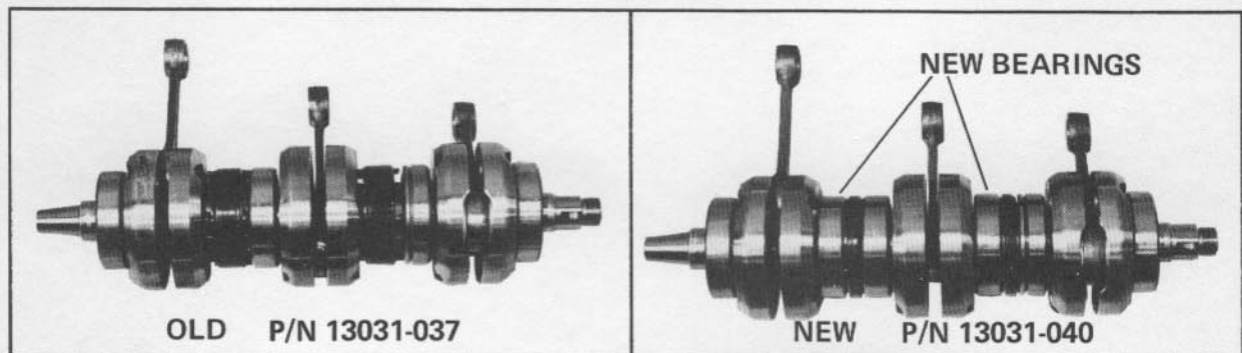
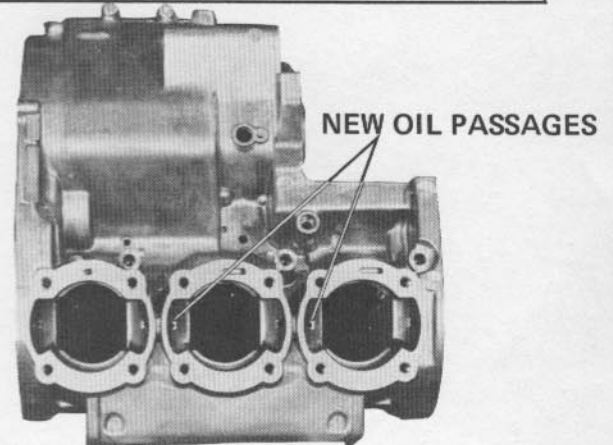
Even though the crankshaft has not been a serious warranty problem on the S2, there have been some cases of crank bearing failure on this model. As a result, the factory has decided to modify the crankshaft/crankcase assembly.

All S2's, engine number S2E-18507 and above, have been fitted with a 6 main bearing crankshaft (P/N 13031-040). It is similar to the crankshaft used on the H1. This new setup reduces crankshaft flexing, and distributes the engine load more evenly for smoother, quieter operation. The oil seals and bearing collars have also been modified so that the 6 bearing crankshaft can be installed on older S2's which were originally equipped with 4 bearing units.

To improve lubrication of the two new bearings, additional oil passages have been bored into the upper crankcase half. These cases have been installed on all S2's from engine number S2E-24749 up. The part number is unchanged.
