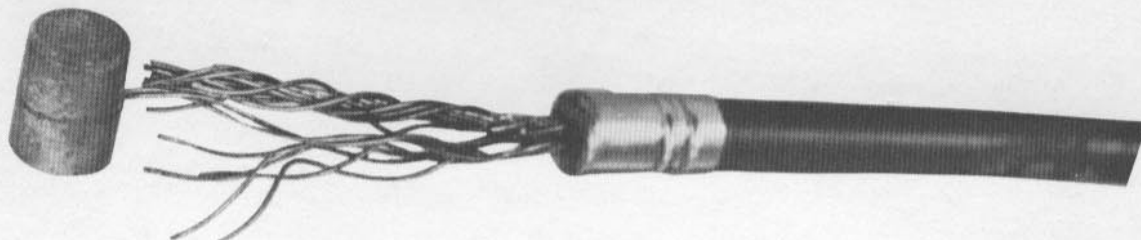
Clutch cable breakage has been a regular problem on the S1 and S2. This is primarily the result of excessive wear at the hand lever. The cable flexes at the lever and the cable strands break at the lead nipple.
