©Kawasaki Motors Corp 1974 Printed in USA

PROBLEM:

EARLY H.T. WIRING

LATE H.T. WIRING

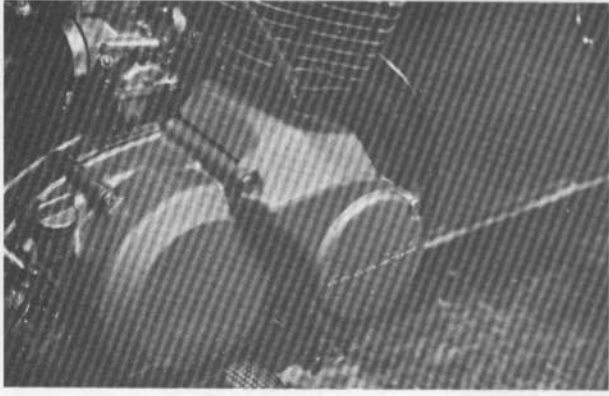
The spark plugs generally are not the cause of the problem. We have found the high tension wiring leaks electricity to adjoining metal engine parts under high voltage loads. New spark plugs require less voltage to fire because the electrodes have sharp edges. As the plugs are used, these sharp edges are rounded off by high energy discharge and erosion from heat and chemical action in the combustion chamber. Consequently, they require an increasing amount of voltage to fire as mileage accumulates. Worn spark plugs, over-rich oil pump settings, or incorrect fuel mixtures demand more voltage from the ignition system to fire the spark plugs. These conditions "back up" the voltage in the secondary wiring until it jumps through the H.T. cord insulation to an inviting engine ground rather than fire the plugs.

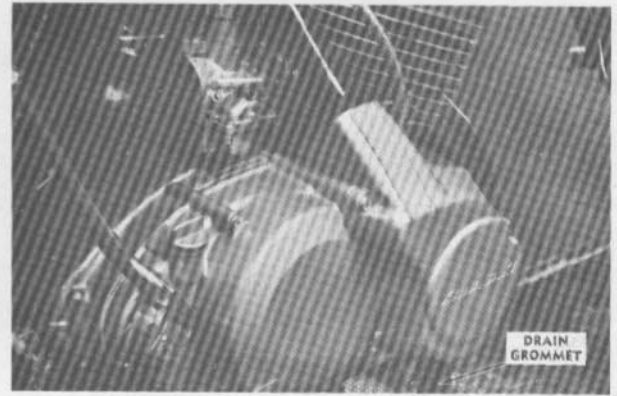
KAWASAKI has developed a set of high tension components which, after thorough testing, has proven completely reliable and eliminates the insulation leakage problem. The purpose of the new components is to re-route the H.T. cords so they are a safe distance from metal engine grounds like the oil pump, oil pump cover, engine cover, cylinders, carburetors, etc. Additionally, the type of H.T. cord has been changed from DAIICHI brand to Belden, a better-insulated cable.

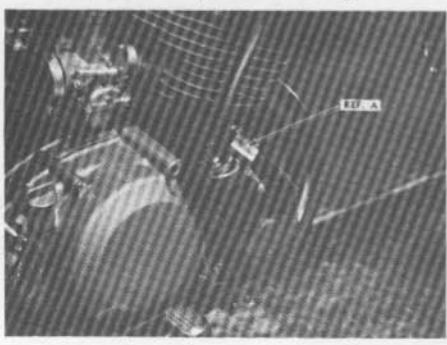
H1 with original H.T. wiring

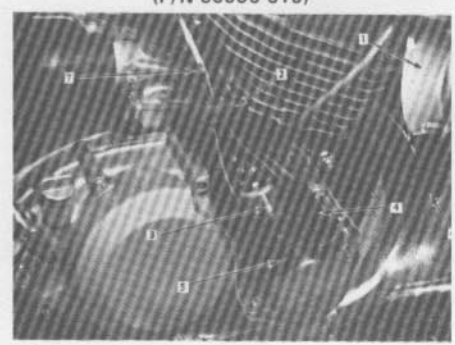
H1 with new H.T. wiring kit
(P/N 99990-015)

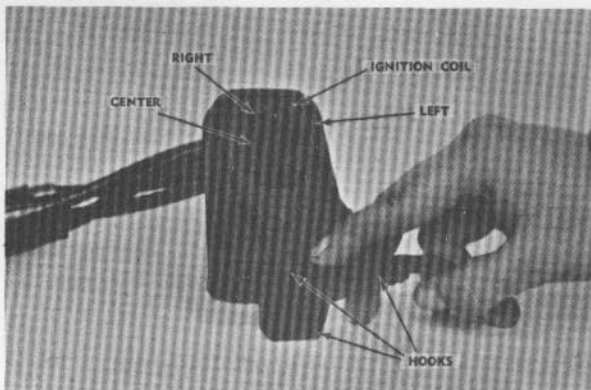
Use Rubber band P/N 92072-013 to fix loom to right frame tube under gas tank.

To save time, use the photo above for inserting the cords in the grommet. The bottom cords should protrude 1" more than the top ones.

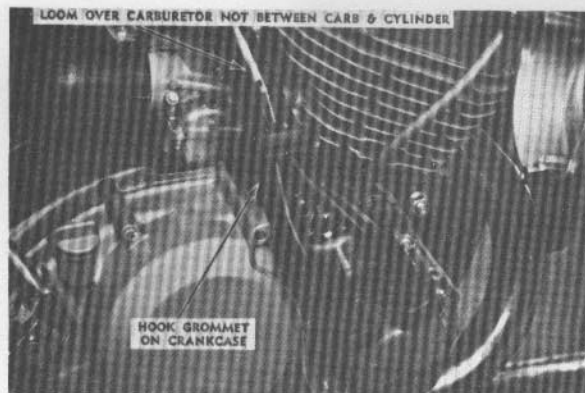
To keep water from entering, make sure the bottom of the grommet is hooked onto the crankcase. Route the H.T. cords over the RH carburetor, NOT between the carburetor and cylinder.

Jam the H.T. cords completely into the distributor cap sockets before installing the piercing screws.
